| | | Doc Nbr: | <b>FT-FI-001</b> |
| Standard Title: | Fermata Connections Field Visual Inspection and Repair Requirements | Current Rev: | 1 |

## Fermata Connections Field Visual Inspection and Repair Requirements

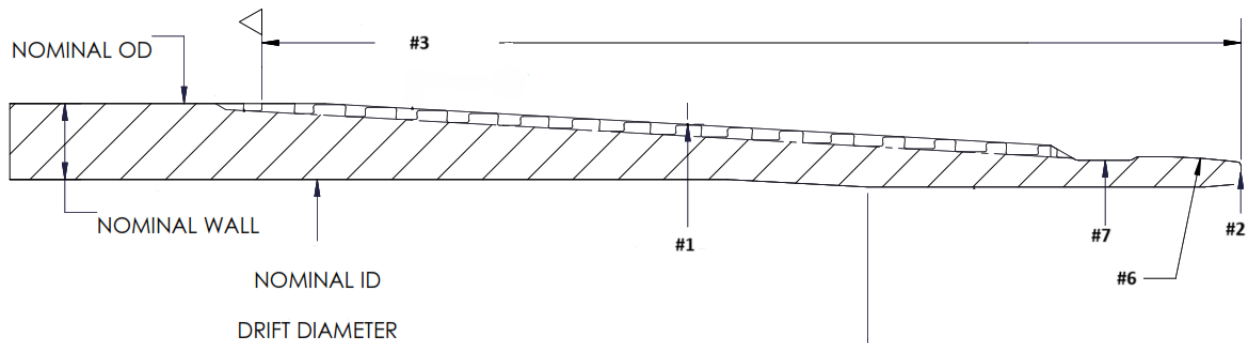
Figure 1. Anaconda GT Pin

#1. This area is the perfect thread area. The use of a file, Scotch-Brite, or similar abrasive tool should be used to remove surface rust, dings, and minor galling if any repairs are required in this area.

#2. This area is the face of the connection. If minor dings, surface rust, galling, or sharp edges are along the face, the use of a file, scotch-brite, or similar abrasive tool should be used for repair. If face is dented resulting in collapsing of the face, the connection shall be rejected.

#4 Any pitting found along the connection shall be rejected.

#6 Seal area, no repairs are acceptable.

#7 Relief area: minor removal of surface rust is acceptable.

5.2 The below figure 1 can be used as a reference guide for visual field inspection and repairable areas.
